The first Passivhaus Archive in the UK

1 Introduction

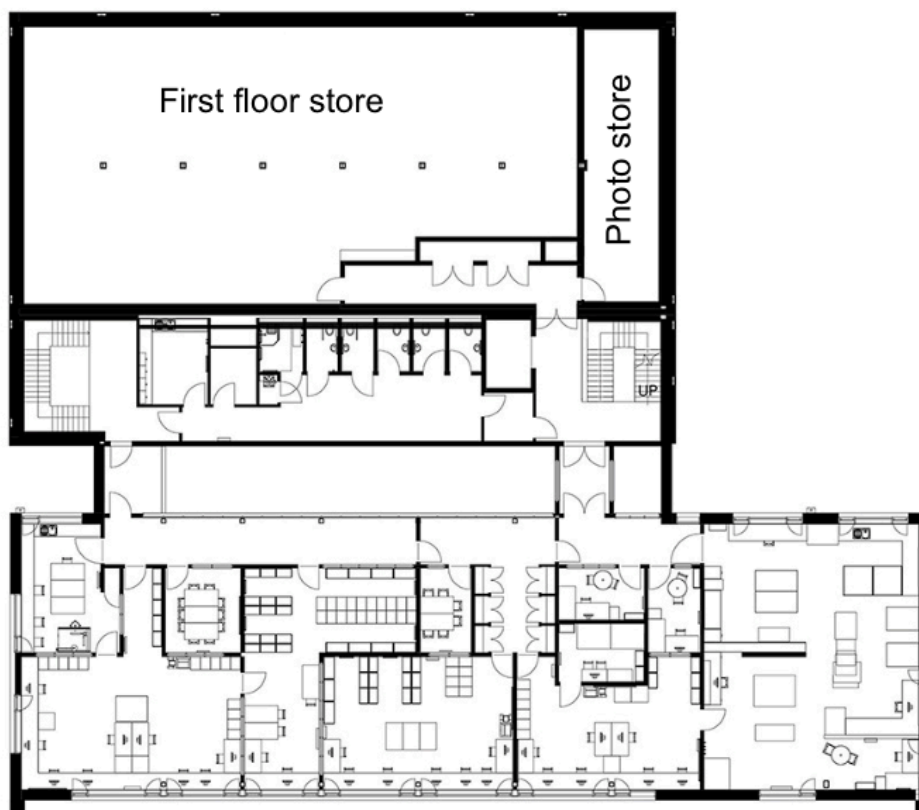
Figure 2: First floor plan of repository and offices. Drawing courtesy Architype.

A cooled and dehumidified storage room for photographs is located on the middle floor (figure 2). This room has a vapour control layer on the walls, floor and ceiling under a continuous layer of internal insulation with a U value of $0.19\text{W/m}^2\cdot\text{K}$ to isolate it from the other storerooms. The photo-store is close conditioned to 12°C and 30% RH whilst the adjacent general storage rooms are allowed to vary between 13 and 20°C .

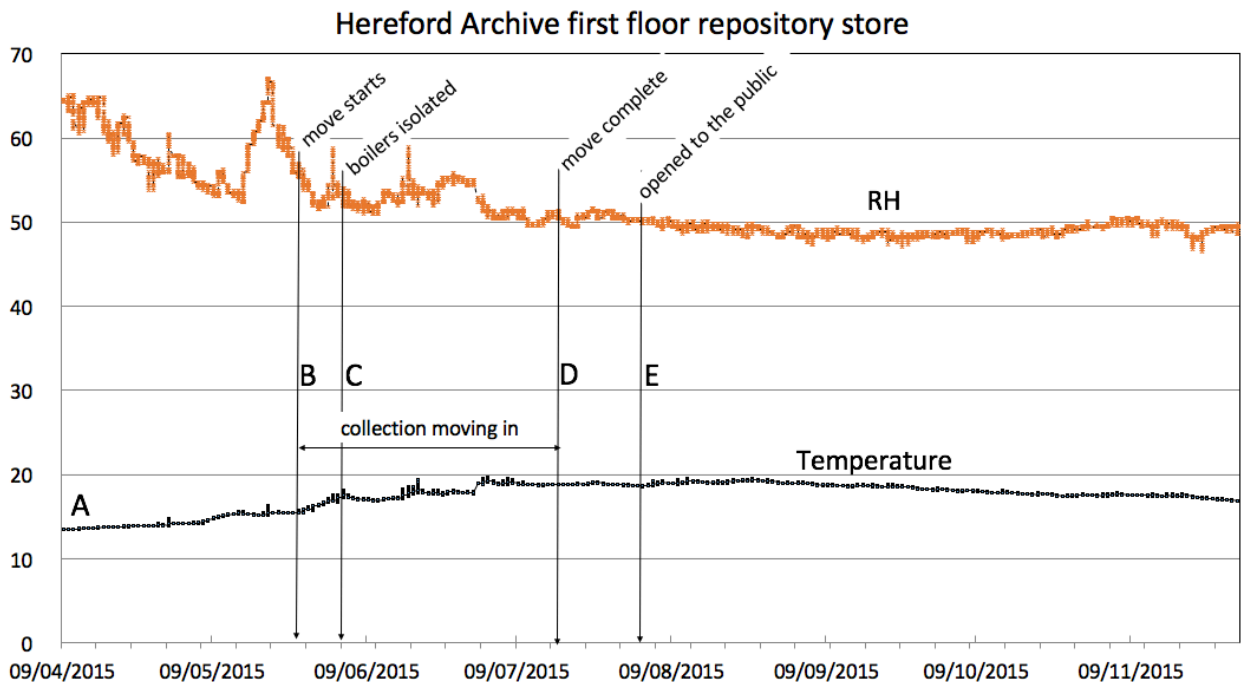
Figure 3: Graph of temperature & RH for first (middle) floor store.

The graph in figure 3 shows the RH and temperature of the middle floor store room for the last 8 months. From point A to C on the graph the temperature rose from 13.5°C to 17.5°C in 2 months. Initially we suspected the temperature rise to be due to lighting as staff were working in the store rooms. On inspection we discovered that the heating circuit was allowing a backflow through the heating pipes in the repository service core even though no heat was required. At some point between B and C on the graph, a Building Management System (BMS) fault caused the heating to come on in the repository. We also spotted that the desiccant dehumidifier for the photo store had been installed backwards. This meant that it was operating very inefficiently leading to additional heat gains in the repository building.

From B to D on the graph we can see the impact of moving the collection into the building. Over this period the lighting was on during the day and staff moved in and out of the stores leading to fluctuation in temperature and RH. The move was complete by the 17th July 2015 from which point conditions can be seen to stabilise.

As an example, following a sensor fault, the BMS reported a low temperature in one of the stores and automatically switched the heating on. This resulted in a small but unwanted rise in temperature (B to C on graph). To prevent a recurrence, the heating system was then isolated. Having seen the very slow cooling of the building without heat input, the archive management agreed that manual control of the heating would be more reliable but this needed to be experienced to be believed.
